ILMC Assessment Report

September 25 2006

Green Lead Pilot Scheme – Site Assessment Form

ULAB Collection Center

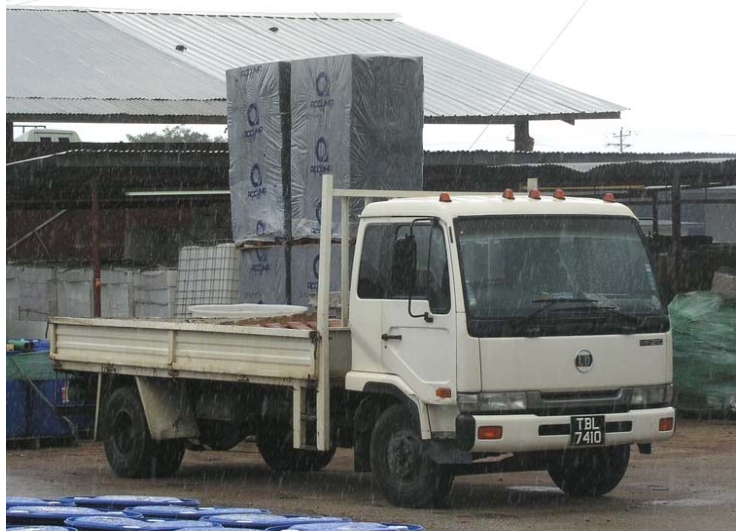
Domestically sourced ULAB are collected in a dedicated and specially adapted truck with drop down sides and back for ease of access. The Drivers are trained in the correct ULAB handling procedures and understand the measures to be taken in the event of a spillage or emergency.

The truck carries four wooden pallets and a plastic container for any leaking batteries.

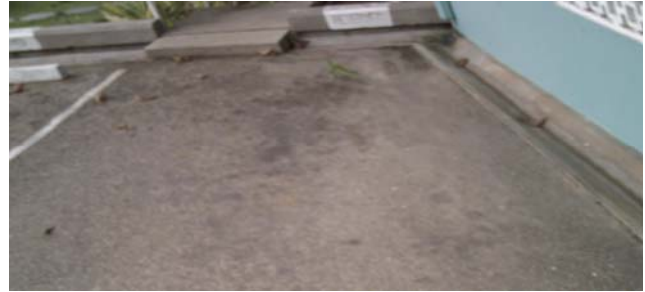
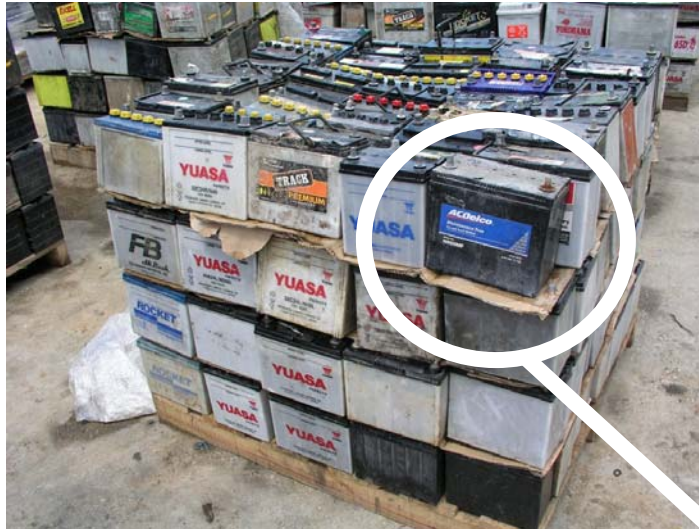
The whole of the ULAB reception, sorting, storage and packing area is concreted with acid resistant concrete and laid in a manner that takes any water or effluent to the drains around the perimeter of the area. Any water or effluent run-off goes to the water treatment plant prior to discharge.

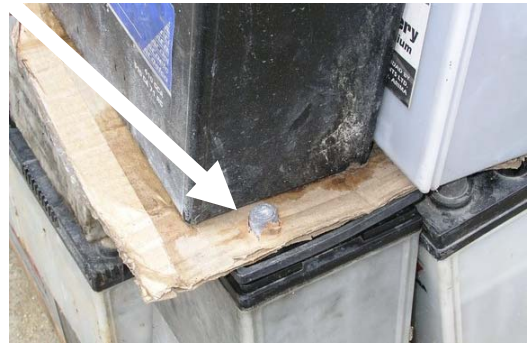
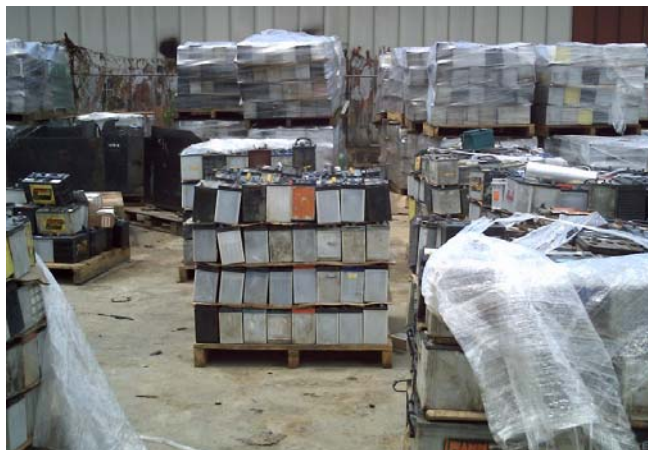
However, all UALB deliveries are inspected to check for leaks and to insert cardboard where it has been missed when the ULAB were stacked or where the cardboard layers are not thick enough and the terminals are protruding, thereby threatening to puncture the case of the battery above.

Any ULAB found to be leaking are placed in a sealed and labeled plastic drum for export. Every effort is made to provide sufficient space in the sorting area to inspect pallets of ULAB and where necessary unpack and repack them, and it was clear that there are designated areas to undertake these tasks.

However, walkways and pedestrian areas were not clearly visible in the yard and it is recommended that where there is mobile equipment, such as fork trucks and low loaders, walkways should be designated and clearly marked in yellow paint and these areas should be out of bounds to trucks and pallets of ULAB should not be “parked” across them so as to ensure an unrestricted exit in the event of evacuation.

It is recommended that consideration be given to marking pedestrian Walkways and introducing a rule that prohibits ULAB being placed on the painted paths, or Fork Truck driving or parking on them. In this way, what is a very thorough operation will be even safer for the workers.

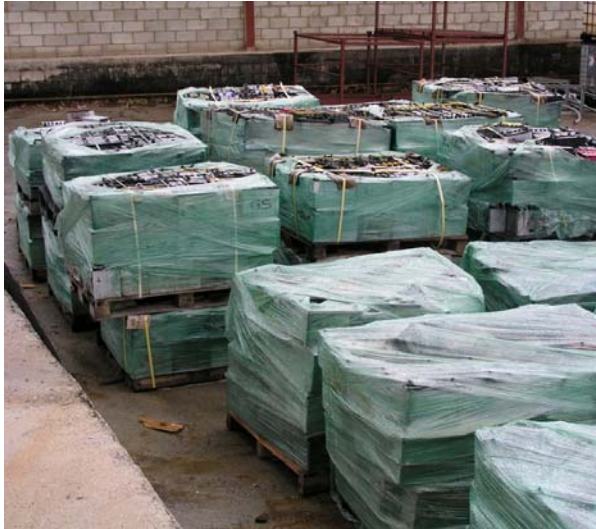
However, some imported ULAB from one of the Caribbean islands were delivered out of compliance with the Green Lead Protocols.

As can be seen in the photograph on the left showing the imported ULAB from St. Lucia they have been palletized and stacked no more than four ULAB high, shrink wrapped in green plastic and strapped. However, there is little or no cardboard between the layers of ULAB and none on the top layer of any of the loads in the yard.

The Company are aware of this problem and are currently trying to educate the ULAB collectors on the Island to comply with the correct packing procedure.

3. Information detailing the correct packing arrangements for pallets of ULAB needs to be sent to the ULAB collection centers on certain Islands together with a copy of the Green Lead Protocols or the Basel Training Manual so that the correct procedures are followed. Compliance with this recommendation will save the Company time and money because repacking the pallets to comply with the Protocols will not be required.

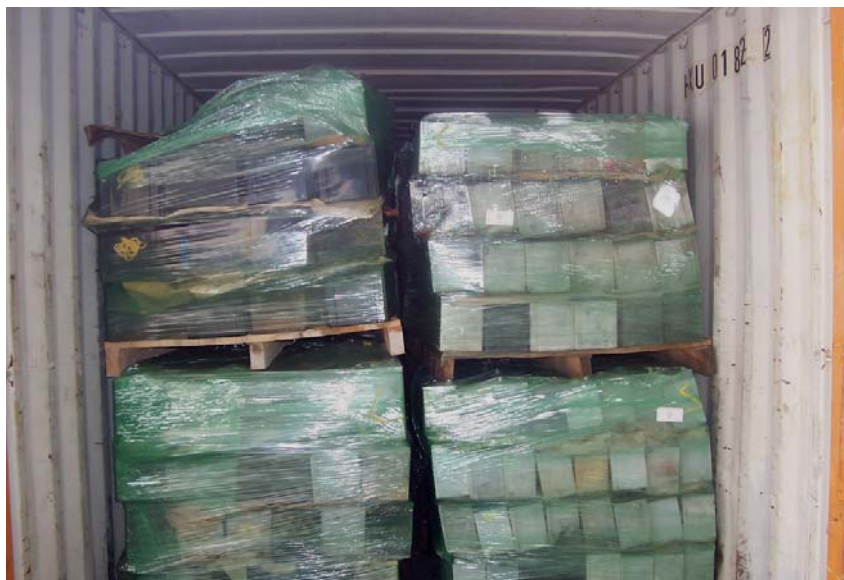
On the day of the site visit the export containers were empty, but a few days later I received a photograph taken by an Independent Bureau Veritas inspector showing the pallets stacked with ULAB in the container.

Clearly, the ULAB have been heavily shrink-wrapped and unlikely to move in transit. The pallets have been packed well, but as an observation and a recommendation, there should be bracing at the end of the container to minimize any movement of the pallets in transit, particularly as they are stacked two high. This point was been noted by the Company and improvements made.

2. The second recommendation, which is already being addressed, concerns the packing of the containers and it is suggested that bracing should be placed at the door end of the container to make sure that the ULAB on the pallets do not move. The pallets are staked two high in the container, which is quite safe as they are packed closely together and cannot topple over.

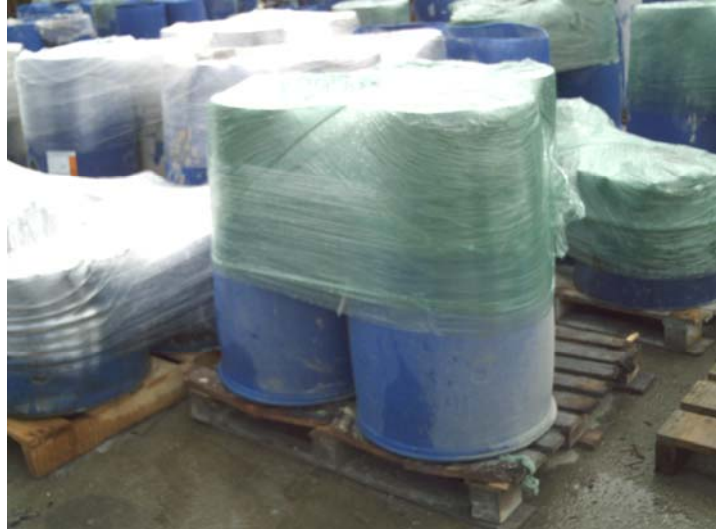
Small, 6 volt motorcycle batteries, USB and security batteries, and all leaded drosses are stored on site in 45 gallon plastic drums. The drums have lids, but they are fitted loosely until the drums are full. The lids are then pushed into position and the lid and the top of the drum shrink wrapped to prevent any spillage during transit. The drums are palletized, strapped and loaded into the containers for export. No photographs are yet available for the plastic bins loaded into the container for export.

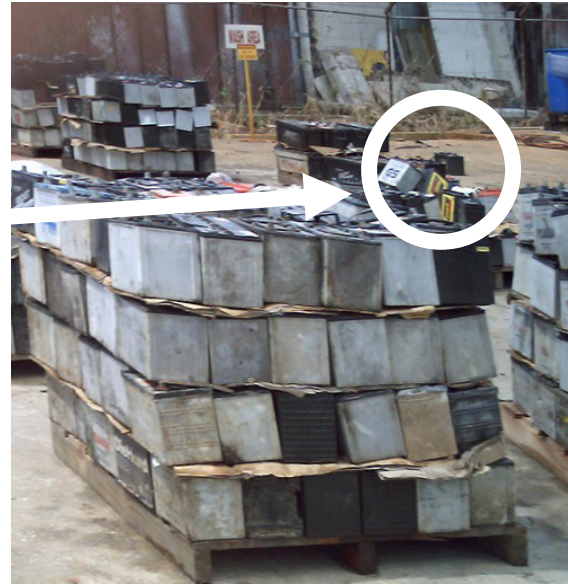
1. Great care is taken by the operators in the yard to check the palletized ULAB delivered to the Center. The Operators are looking for leaking batteries, poor packing, and trying to keep each layer of ULAB as even as possible. In the course of their work it is necessary to unpack and repack pallets of ULAB. Inevitably this means that ULAB end up on the concrete during this process.

In the absence of any clearly defined walkways and pedestrian areas in the storage compound, ULAB could be placed, albeit with care, around the packing area and could form a tripping hazard or be placed in the path of a Fork Truck.

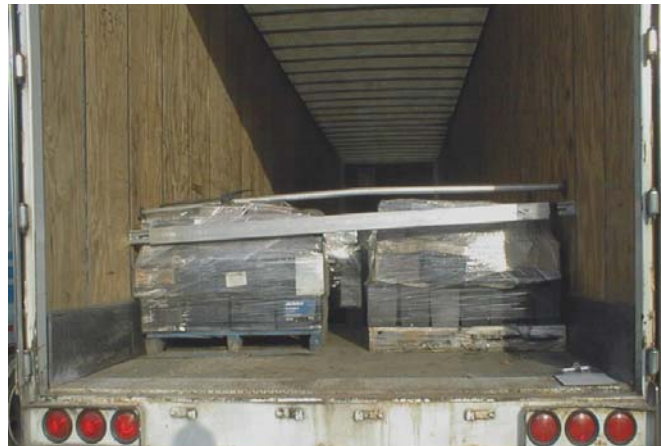
However, pallet size and sometimes weight restrictions will mean that the pallets are not always loaded tightly up to the end of the container. Weight restrictions will also mean that there might be a small pallet of ULAB that is not packed tightly against the other pallets. Therefore, when the doors are closed there could be a sizeable gap between the pallets and the doors, where the top tier of palletized ULAB could fall and possibly crack and leak electrolyte. So bracing shown here, should be placed across the trailer to retain the pallets of ULAB.
